# Proper Grounding System Resolves Electrical Issues at Gainesville, Florida AM Radio Stations

WDVH and WTMN were recently acquired by MARC Radio Group, LLC., Gainesville, Florida. The two stations share transmission facilities and a tower (Cover Photo). They were in poor shape at the time, regularly beset with lightning strikes and power surges that resulted in damaged equipment and off-the-air downtime. Both very costly. The station owners wanted to find out what was causing these electrical mishaps, and how they could prevent them from happening again.

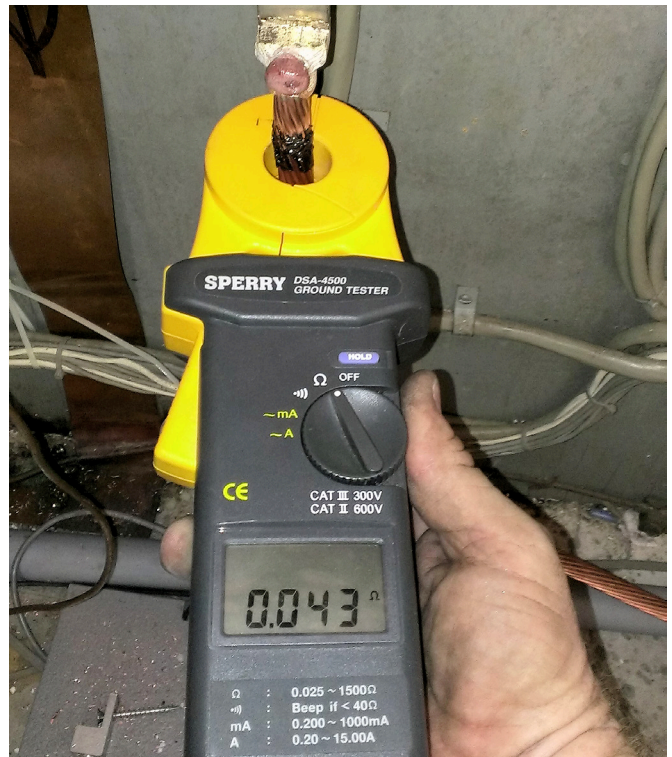
FIGURE 4.

After the new grounding and bonding was installed, the ground resistance of the resultant system measured below 1 ohm. All internal equipment was bonded to a new interior grounding busbar, including the telephone system and transmitter equipment. The interior bar was further connected to the external ground system.

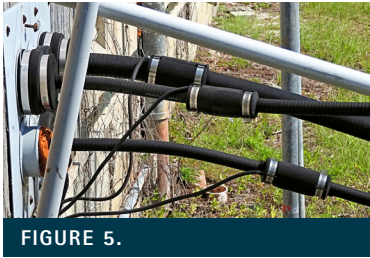
The shield of the coax going to the tower is bonded to the external grounding bar by means of Andrew's Cuffs. The majority of lightning energy on the shield is thus diverted to the extensive external grounding system, rather than the internal equipment where it can do damage.

The coaxial transmission line that goes to the tower is bonded to the external ground bar through an Andrew's surge arrester, sometimes called an Andrew's Cuff (Figure 5). It clamps to the coax shield and catches lightning energy that may come down the shield of the cable toward the facility and the transmission equipment. The cuff is connected through double lugs to the ground bar and then to the buried ground field.
